# Technical Bulletin

**Subject:**  
ATF Flow Noises  
on Cold Tiptronic Transmission

**Number**  
9402

**Models Affected:** *911 Carrera Model Year 1995  
with Tiptronic Transmission*

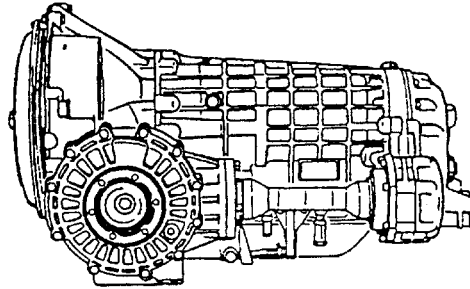
**Concern:** In isolated cases, ATF flow noises may occur on cars with Tiptronic Transmissions in a cold condition or, when driving, a scraping noise might be noticeable.

**Repair Procedure:** Increase the ATF level in the transmission. This means at 80°C (176°F ATF temp) the ATF quantity has to be increased to 15mm above the 80°C maximum mark on the inspection glass on the side of the transmission.

In addition, the ATF lines near the transmission must have a minimum clearance of 20mm to the body. If not, the lines should be slightly bent outward.
